## Inspection Report

**Mine Name:** Western Utah Copper Company

**Permit numbers:** M0010067,  
E0010159, E0010161

**Inspection Date:** March 12, 2008

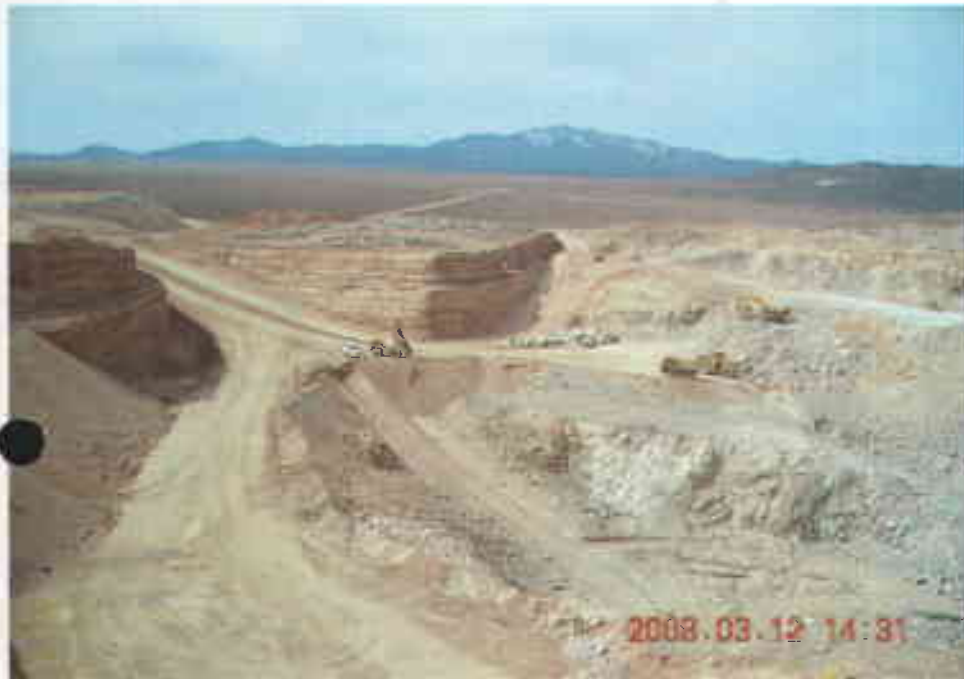
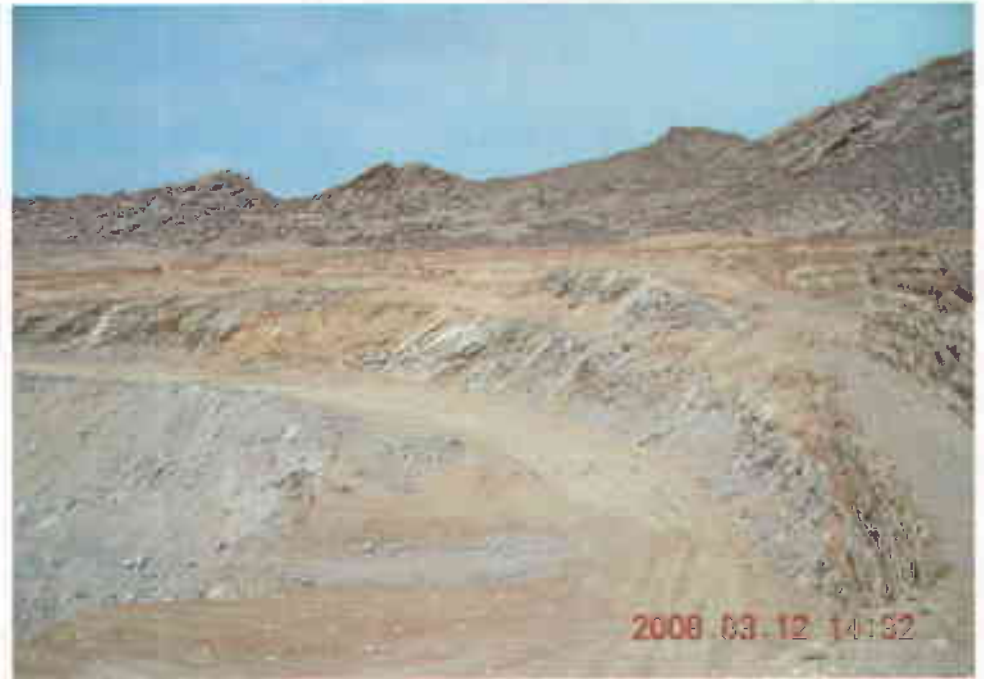
HIDDEN TREASURE PIT

The mine site related to permit # M0110067 was active and the first area we visited was the Hidden Treasure Pit that was being actively mined. The highwalls associated with the recently excavated pit are mainly colluvium or alluvium. There are areas of cracking or failure considered unstable in certain areas due to blasting damage. According to Ron Wunderlich, MSHA had requested that another bench be placed for safety, expanding the pit size. This may require submitting a permit amendment to DOGM. The ore seam was exposed and waste rock was being removed in the pit.

The exploration notices for Copper Ranch and the Bawana Mine be reviewed to determine adequacy. The Hidden treasure pit acreage be checked and any modifications to the plan be submitted to make sure the acreages of disturbance are keep up to date and accurate.

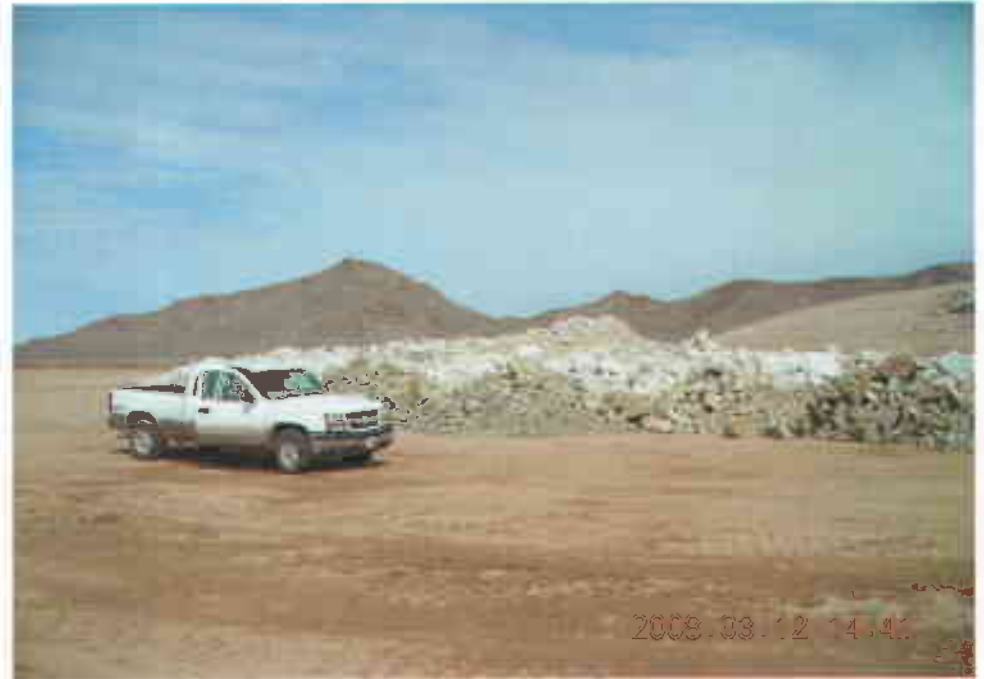
ORE FROM HIDDEN TREASURE

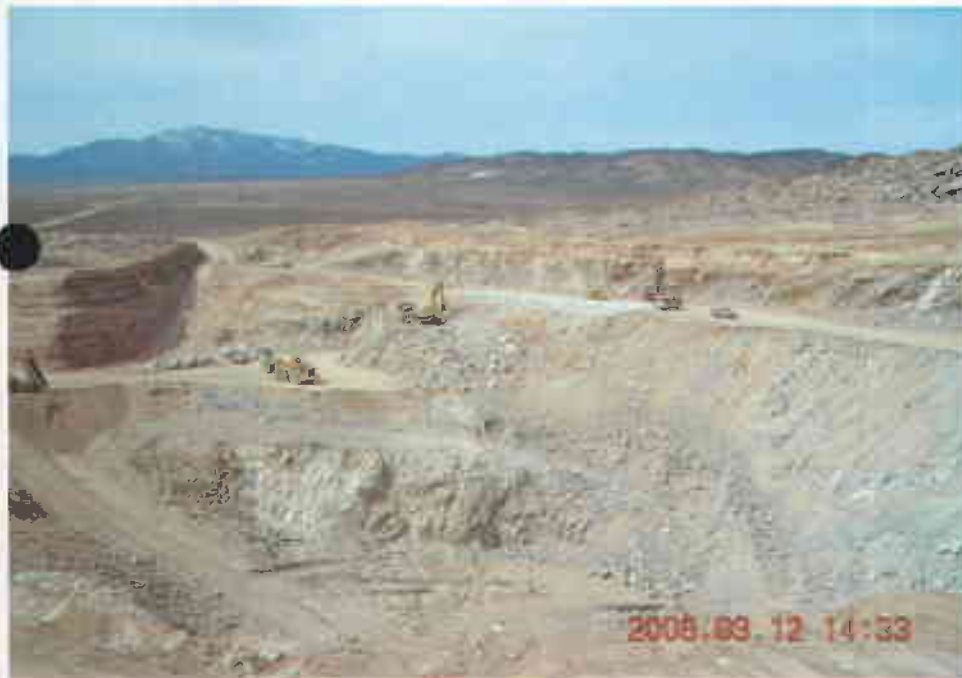
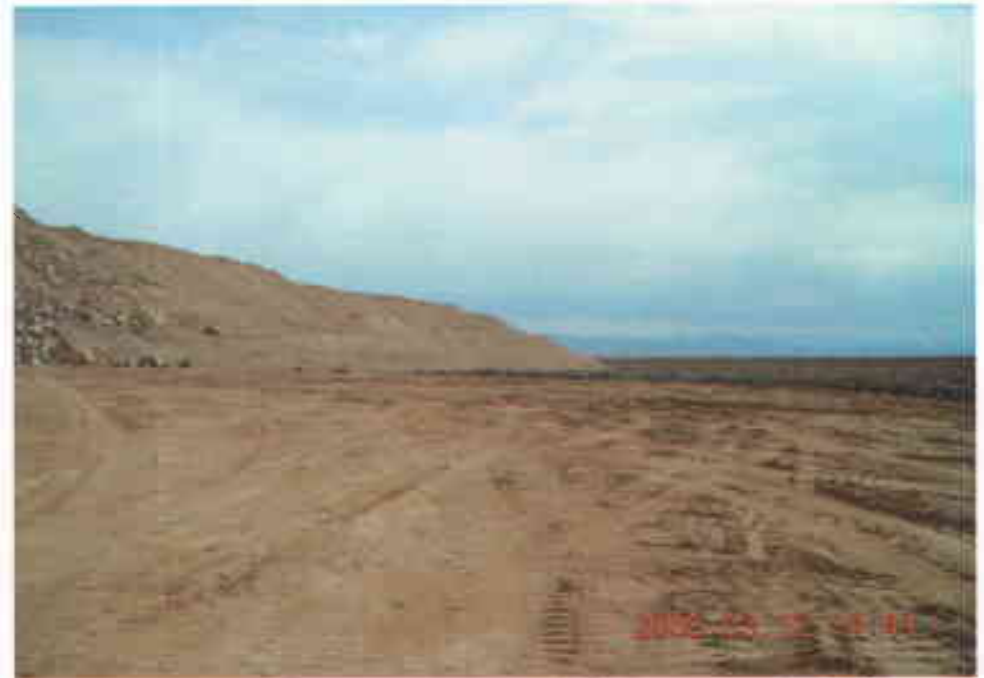
PAD AREA BELOW WASTE  
DUMP

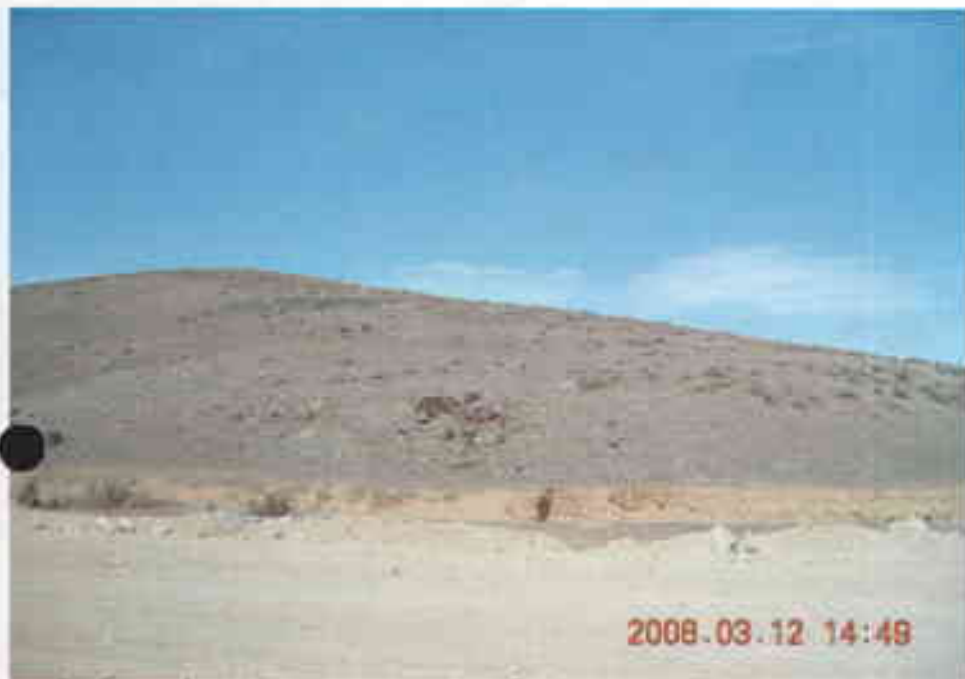
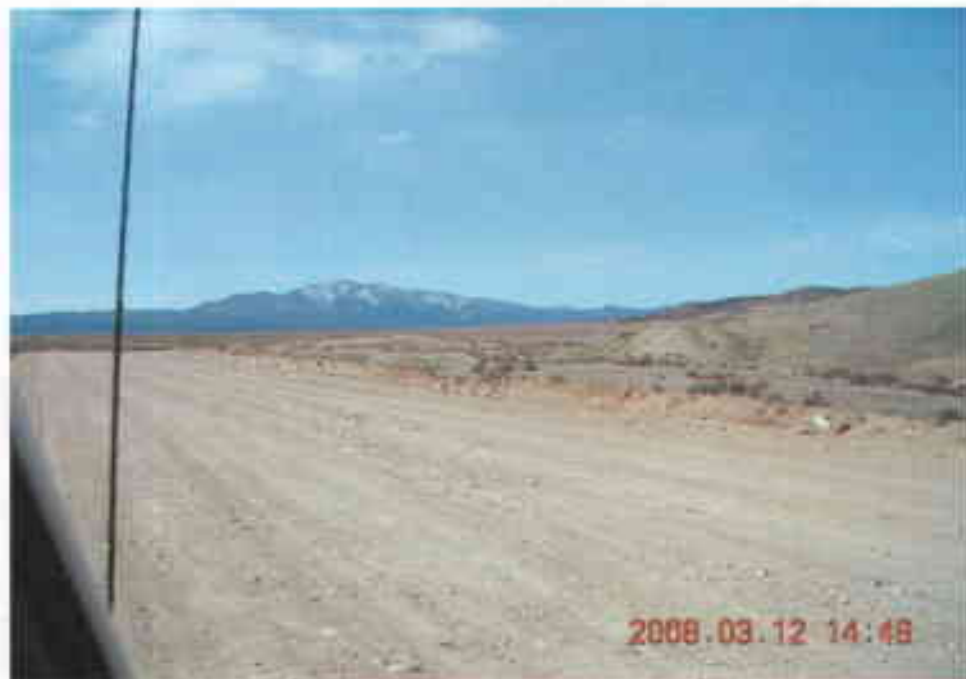
E/001/157 COPPER RANCH EXP

The next area we visited was the proposed Copper Ranch Exploration site, permit #E0010159, where drilling was being carried out in the road adjacent to the knoll that will be explored. The permit is currently being

reviewed and a bond has been submitted. We talked about the placement of the exploration roads and it was mentioned that if the roads were not placed as permitted that an amendment would be required to the permit.

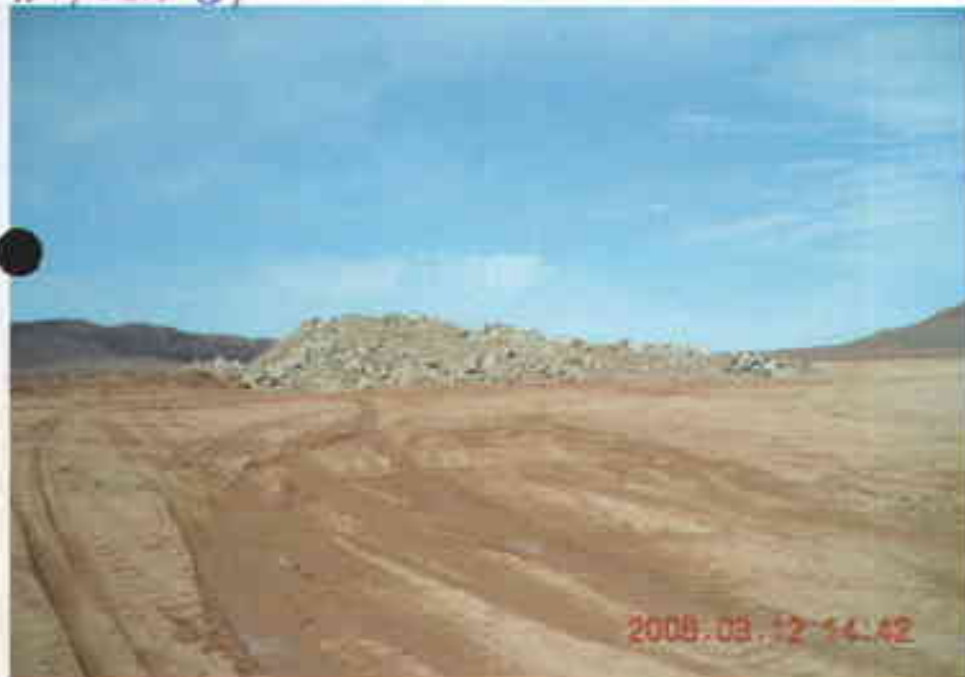
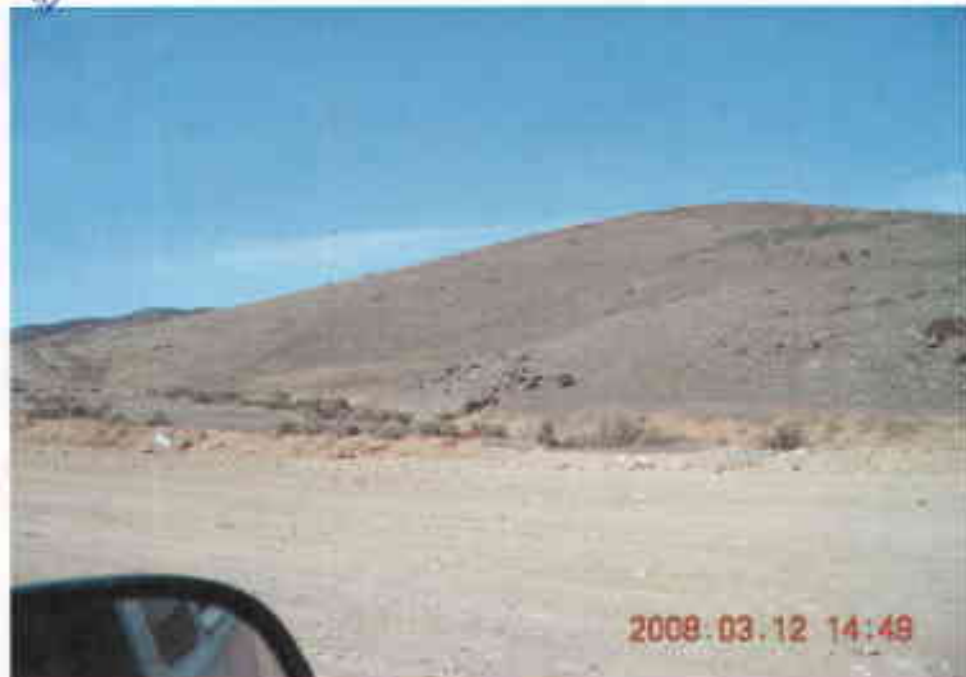
ORE - HIDDEN TREASURE

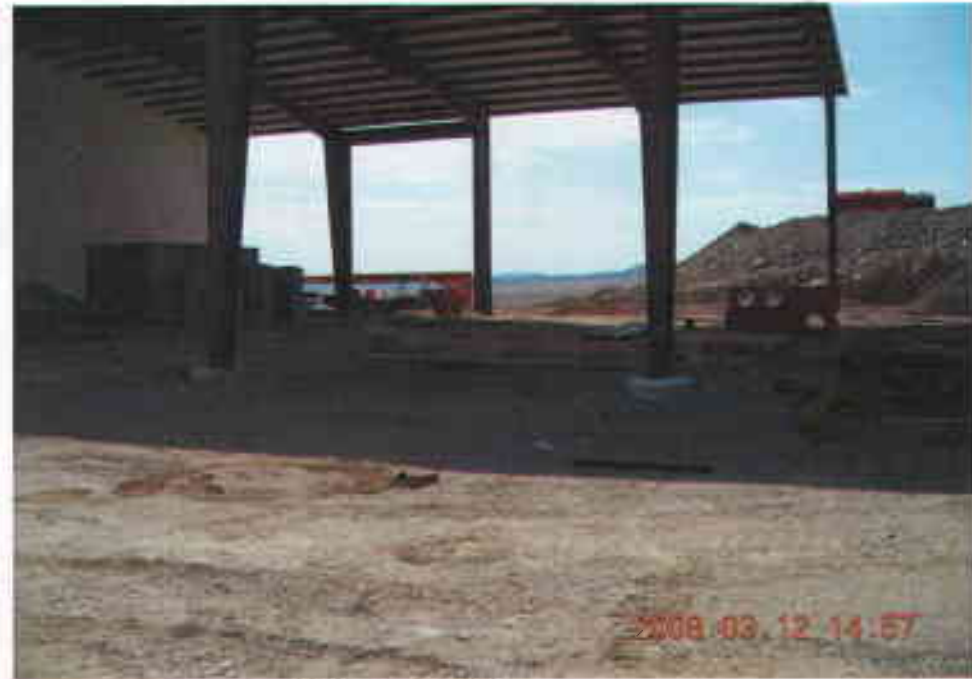
MILL SITE

The next area visited was the mill site where we toured the mill that is in the process of being constructed, including ball mills, floatation tanks, and other project in various states of completion.

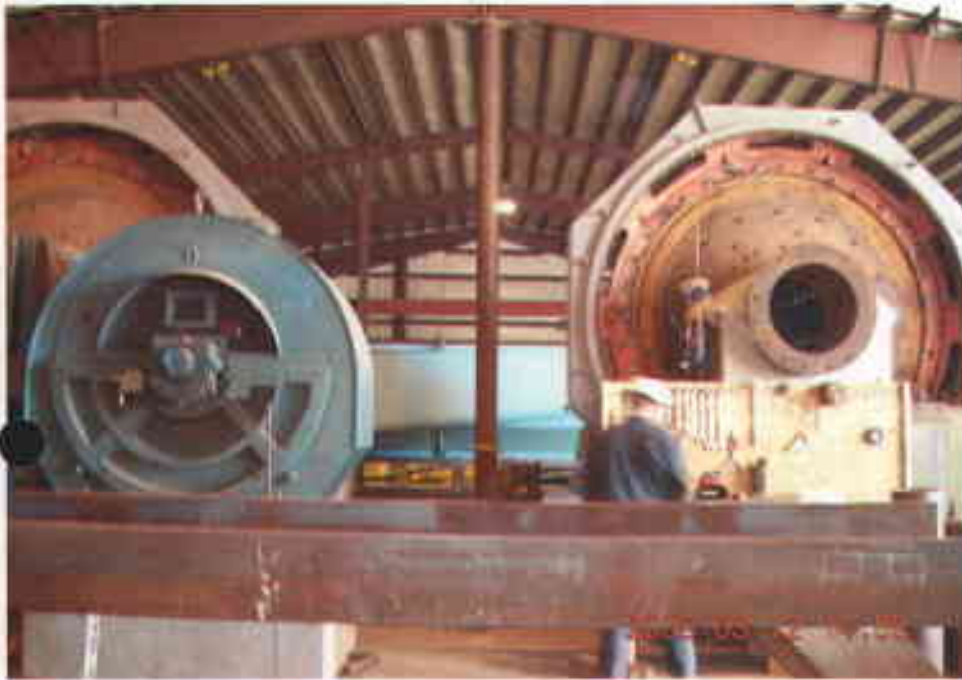
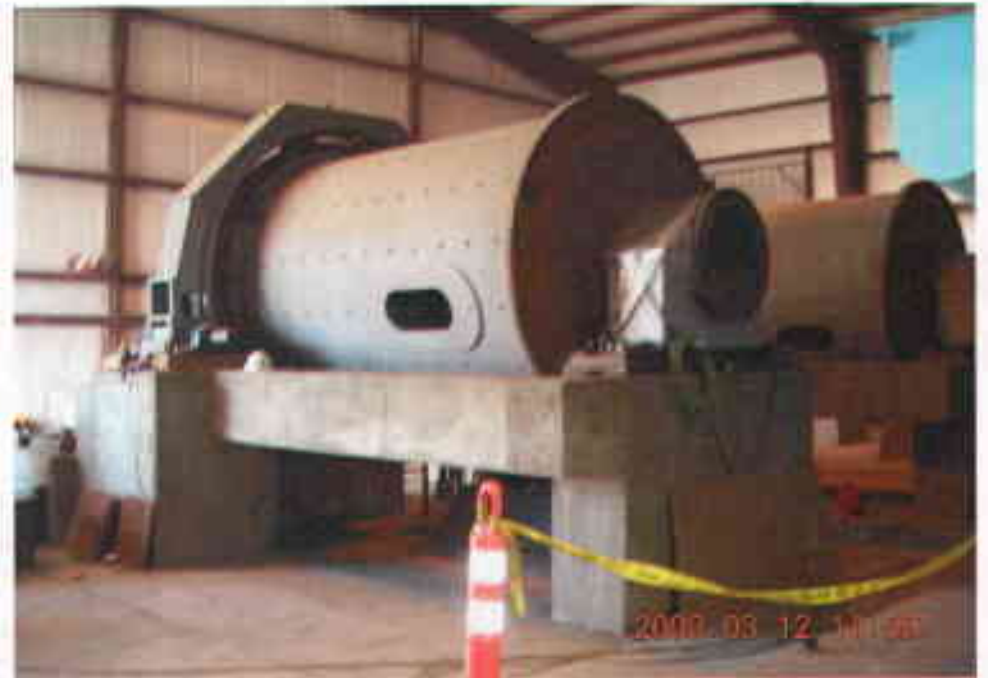
BALL MILL BEING CONSTRUCTED

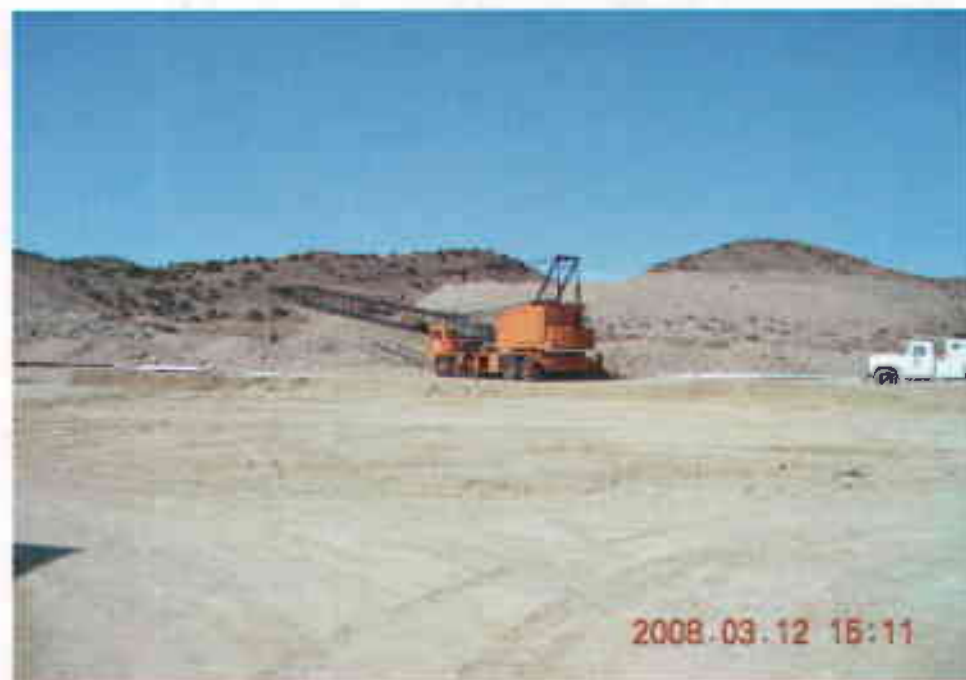
LOOKING N FROM MILL

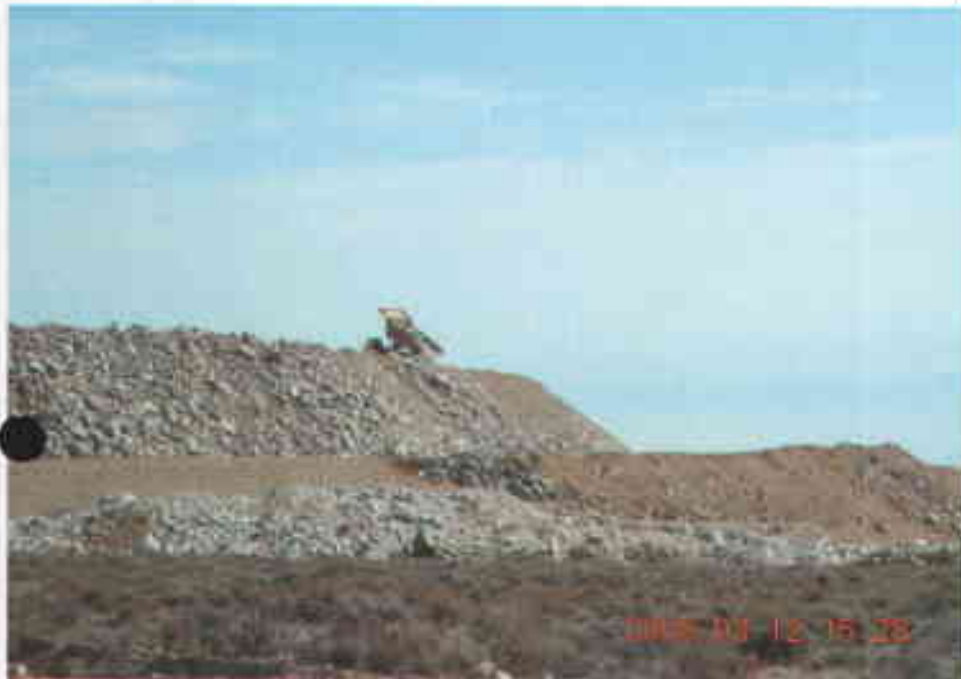
DUMPING OFF WASTE DUMP

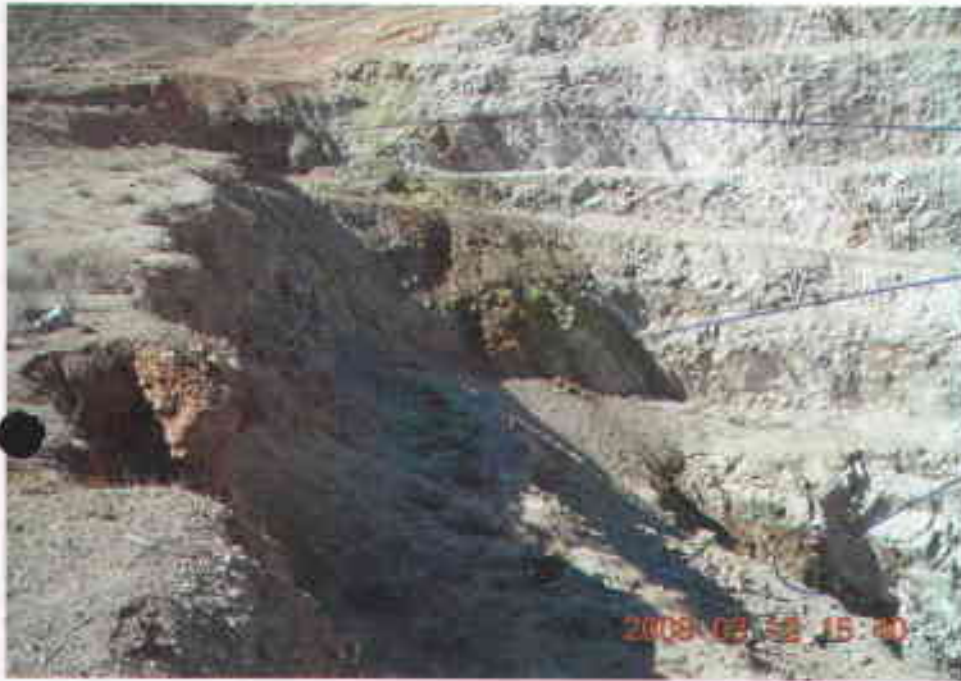
BAWANA PIT EXP SITE  
E/001/161

We then toured the other areas in the vicinity that will be permitted as small mine or exploration permits. This includes the Maria pit and Bawana pit. The Bawana Mine permit # E0010161, was looked at since it is going to have several underground exploration adits. The issues associated with the Bawana Mine exploration permit are that the roads leading to the new portals appear to be unstable and will be upgraded. The roads will be constructed in a previously disturbed pit and the reclamation costs will be only the costs to put the roads back to original condition and close the portals.

THREE PORTALS  
PROPOSED
